Manhole Inspection Summary

Manhole # S290__040MH

Insp Date: **4/13/09 12:20 PM**

Location Address: **1203 SCOTT ST**

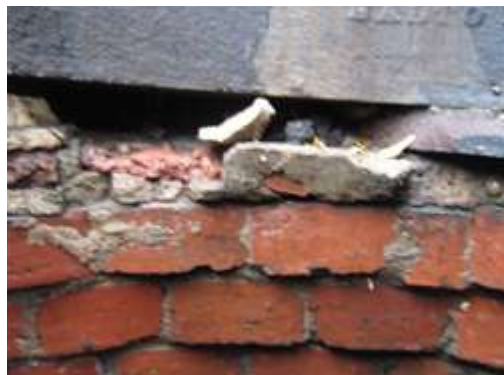
Defect 2

Frame Offset: **1** (in.) Condition: ☐ Sound ☐ Cracked ☒ **Leaks**

Condition: ☐ Sound ☐ Cracked ☐ Root Intrusion ☒ **Loose Brick** ☒ **Deteriorated**

Infiltration: ☐ None ☒ **Joint** ☐ Cracks ☐ Mortar ☐ Roots ☐ Wall

infiltration from frame & from chimney joint; chimney deteriorated with loose brick & mortar

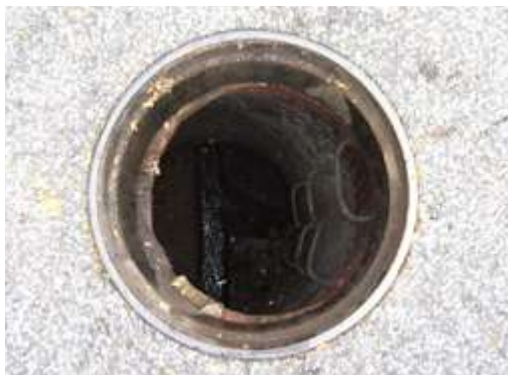
Defect 1

frame offset

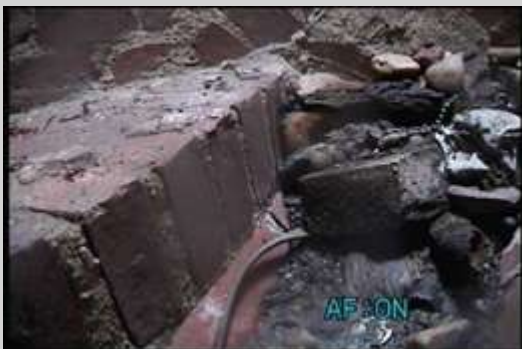
3 O'Clock Inflow

Abandoned connection

Connects To: **Stub connection / abandoned**
